# **Demonstration of Remotely Operated Vehicles to Aid Underwater Inspection of Corps of Engineers Navigation Structures**

Winfield Locks and Dam 13—17 August 2007

James H. Lever and Gary E. Phetteplace

Final report

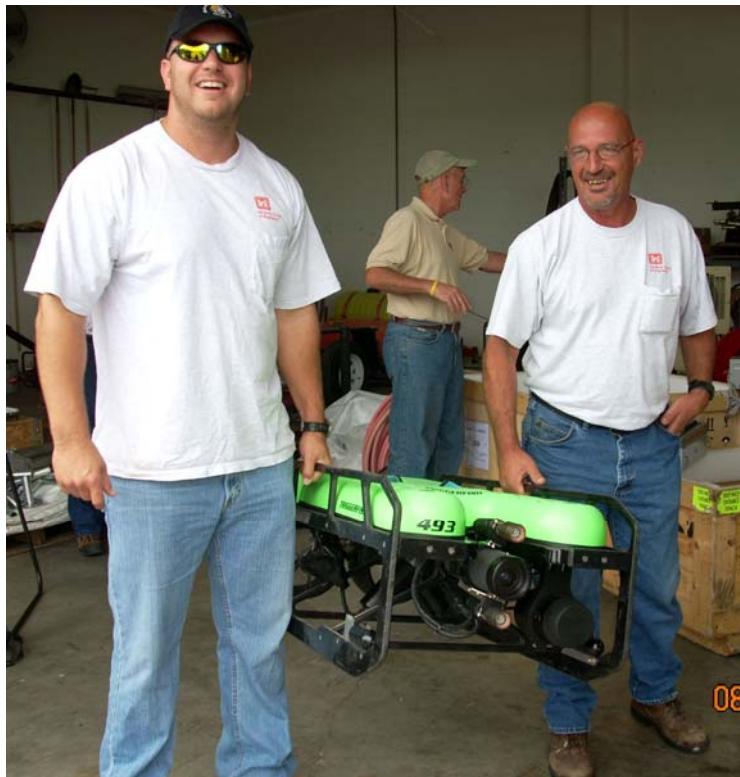
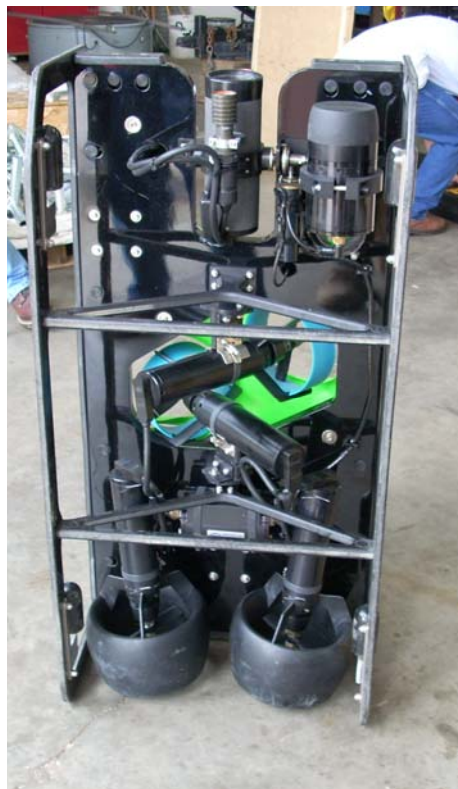
Figure 1. Deep Ocean Engineering *Triggerfish* ROV carried by two divers (top). Underside (bottom) shows longitudinal thrusters at bottom, diagonal thrusters in middle, tilting video camera and light in top-center slot, and BlueView imaging sonar in top-right corner.

Figure 1 shows the Deep Ocean Engineering (DOE) *Triggerfish* vehicle. As tested with sonar attached, it weighed about 33 kg and measured  $1.09 \times 0.53 \times 0.41$  m. It has a tilting color-zoom video camera, two tilting lights, and a fixed-position BlueView P900E-20 imaging sonar at the front of the vehicle. It uses two longitudinal thrusters for fore/aft propulsion and two diagonal thrusters for vertical/lateral propulsion. Its depth rating is 152 m. Navigation aids include a fluxgate magnetic compass and a depth sensor. The modular topside equipment includes an operator control unit with joystick to drive the vehicle, auto-depth and auto-heading functions, and a video display with data overlay. The tether is 2 cm in diameter. The system cost as tested was about \$57,000 exclusive of the sonar.

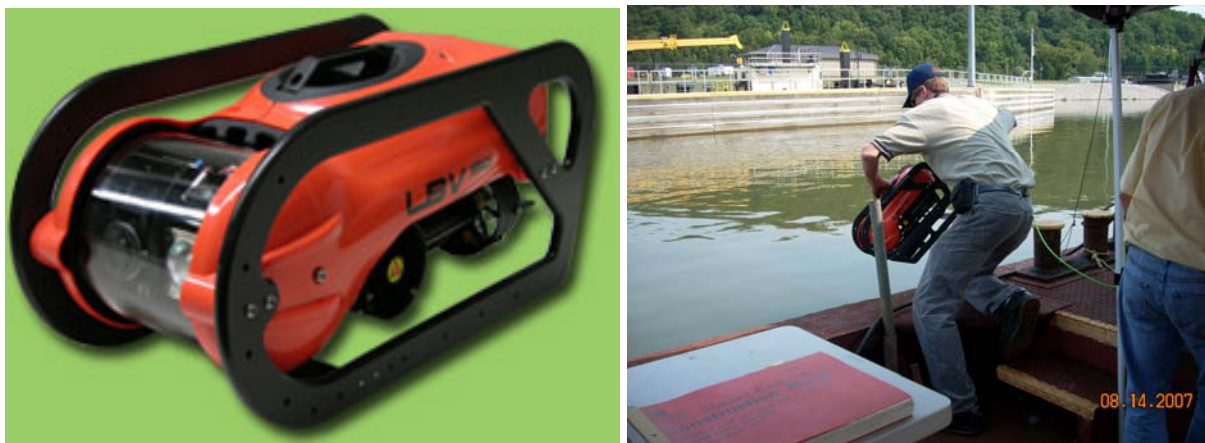
Figure 2. SeaBotix LBV150SE ROV (left) with color camera, black and white camera, and light mounted on tilt frame behind front cylindrical window, and one-person deployment/recovery (right).

Figure 2 shows the SeaBotix *LBV150SE* vehicle. As tested with sonar attached, it weighed about 13 kg and measured about  $0.53 \times 0.24 \times 0.35$  m. It has a tilting camera assembly consisting of a fixed-focal-length color video camera, LED lights, and a fixed-focal-length low-light black and white video camera mounted at  $70^\circ$  to the color camera. The BlueView P900E-20 imaging sonar was mounted horizontally on a skid under the

vehicle. The ROV uses two longitudinal thrusters for fore/aft propulsion, one thruster for vertical propulsion, and one thruster for lateral propulsion. Its depth rating is 150 m. Navigation aids include a fluxgate magnetic compass and a depth sensor. The compact topside system integrates an operator control unit with joystick to drive the vehicle, auto-depth and auto-heading functions, and a video display with data overlay. The tether is 0.76 cm in diameter. The system cost as tested was about \$26,300 exclusive of the sonar.

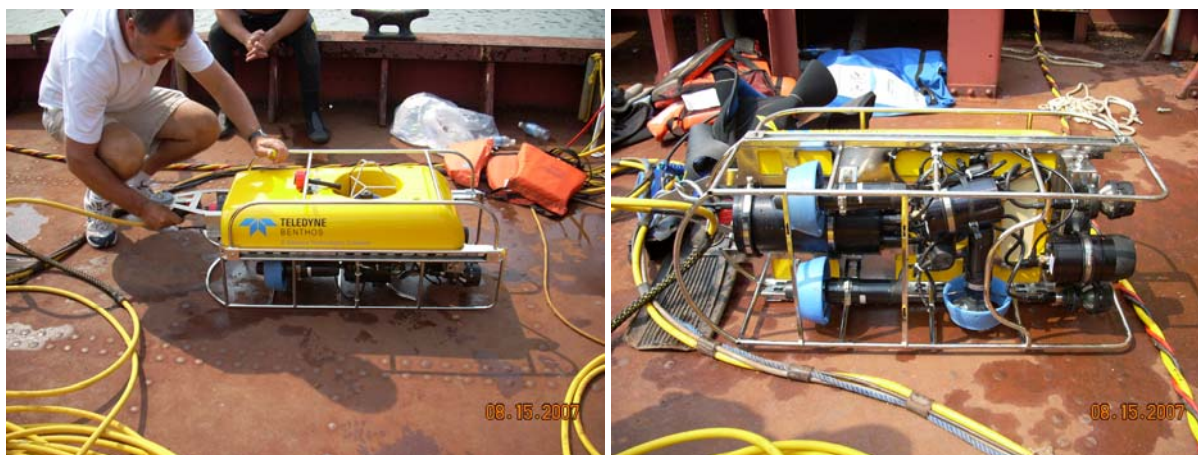
Figure 3. Teledyne-Benthos *Stingray* shown from above (left) and underneath (right) with longitudinal thrusters at left end, lateral thruster and electronics housing in middle, and tilt bar with camera, lights, and sonar attached at right end.

Figure 3 shows the Teledyne-Benthos *Stingray* vehicle. As tested with sonar attached, it weighed about 34 kg and measured  $0.99 \times 0.46 \times 0.46$  m. Under the front of the vehicle, it has an externally mounted tilt bar with color-zoom video camera, lights, and BlueView P900E-20 imaging sonar attached. The ROV uses two longitudinal thrusters for fore/aft propulsion, one thruster for vertical propulsion, and one thruster for lateral propulsion. Its depth rating is 350 m. Navigation aids include a fluxgate magnetic compass, a depth sensor, pitch-and-roll sensors, and a yaw-rate gyro. The modular topside equipment includes an operator control unit with joystick to drive the vehicle, auto-depth and auto-heading functions, and a video display with data overlay. The tether is 1.7 cm in diameter. The system cost as tested was about \$75,000 exclusive of the sonar.

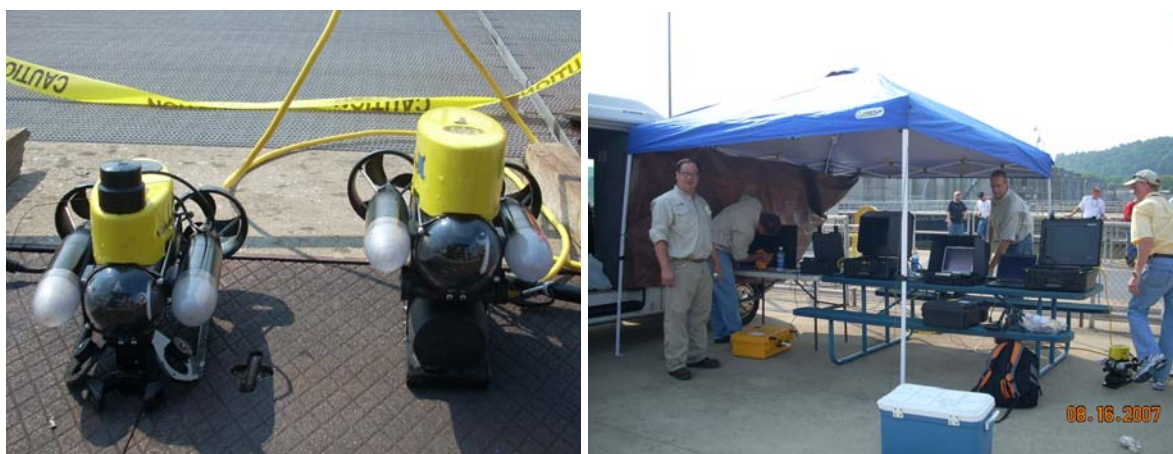
Figure 4. VideoRay's two *Pro 3 XE GTO* vehicles with scanning sonar (left vehicle) and imaging sonar (right vehicle) and topside control and display equipment for both ROVs.

VideoRay brought two complete *Pro 3 XE GTO* systems to the demo (Fig. 4). One vehicle had a gripper claw mounted underneath and a Triton Sea-

Sprite scanning sonar mounted on top. The other had a BlueView P900E-20 imaging sonar mounted underneath. The ROVs with accessories weigh

about 5–6 kg and measure about  $0.36 \times 0.21 \times 0.33$  m. These were the smallest and lightest ROVs demonstrated. They each have a fixed-focal-length tilting color video camera facing forward, fixed front lights, and a low-light black and white video camera facing rearward. Each ROV uses two horizontal thrusters for fore/aft propulsion and a smaller vertical thruster; they are rated at 152-m depth. Navigation aids include a compass and a depth sensor. The compact topside systems each integrate an operator control unit with joystick to drive the vehicle, auto-depth function, and a video display with data overlay. The tethers were 0.8–1.0 cm in diameter. The cost for each *Pro 3 XE GTO* system was about \$27,500 exclusive of sonar and gripper.

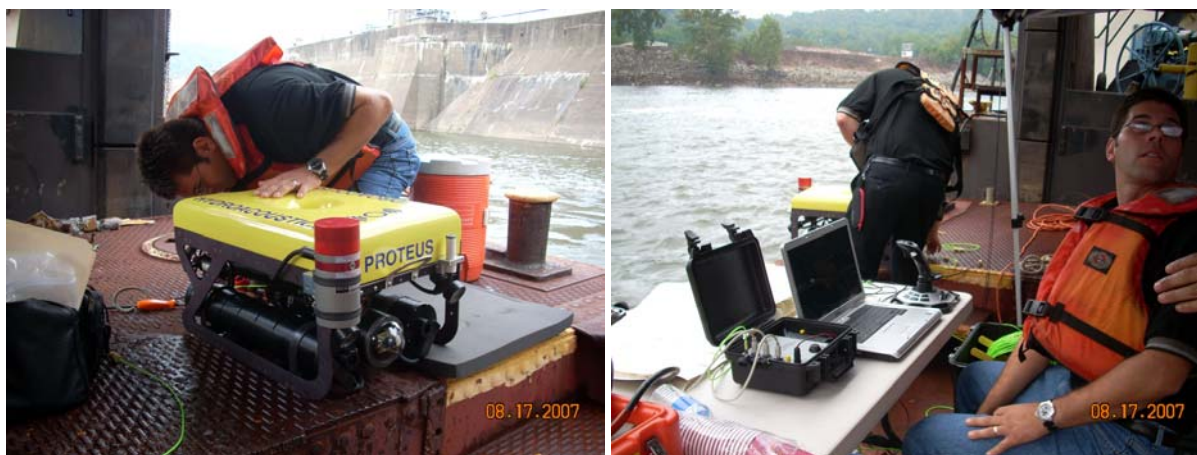
Figure 5. Hydroacoustics *Proteus 500* ROV (left) with vertically mounted Imagenex sonar, tilt color camera, fixed lights, and two longitudinal battery tubes along bottom of vehicle, and (right) laptop-based operator station.

Figure 5 shows the Hydroacoustics *Proteus 500* system. This ROV was powered by on-board batteries (normally Li-Ion but NiMH at the demo) rather than powered via the tether as all other systems demonstrated. Mounted at the front, the vehicle has two fixed-focal-length color video cameras (one tilting, one fixed) and two fixed lights. It also has a vertically mounted Imagenex 881A scanning sonar. With sonar, the ROV weighs about 43 kg and measures about  $0.69 \times 0.46 \times 0.45$  m. The ROV uses two longitudinal thrusters for fore/aft propulsion, one thruster for vertical propulsion, and one thruster for lateral propulsion. Its depth rating is 152 m. Navigation aids include a compass and depth sensor. The topside equipment includes a laptop computer-based operator control unit with joystick to drive the vehicle, and auto-depth and auto-heading functions. The laptop screen can display video and sonar simultaneously in separate windows. The tether was the smallest demonstrated at 0.35 cm in diameter. It is slightly negatively buoyant but floats can be added to provide slight positive buoyancy. The system cost as tested was about \$25,000 exclusive of the sonar.

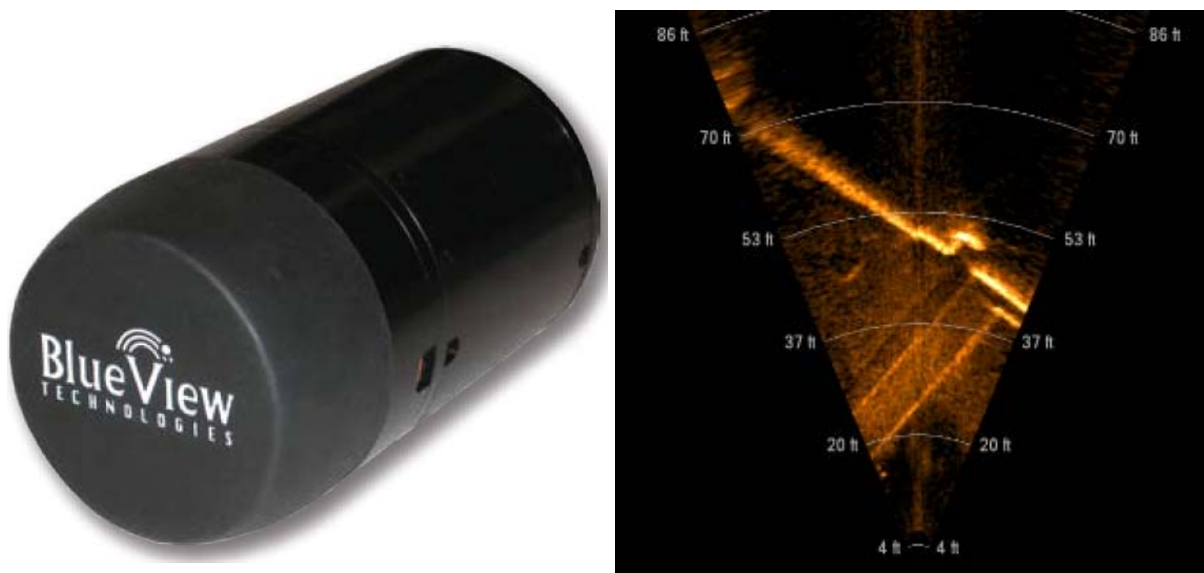
Figure 6. BlueView P900E-20 imaging sonar (left) was mounted on four of the five ROVs. The sonar image taken in the main lock chamber (right) clearly shows the lock wall diagonally from upper left to middle right, the stop-log recess in the wall, the stop-log sill diagonally from lower left, and one of the stop-log alignment blocks near middle left.

The BlueView P900E-20 is a multibeam sonar that creates two-dimensional (2D) images of intensity versus angle and distance across a  $45^\circ \times 55$ -m field of view at update rates up to 10 Hz (Fig. 6). The sonar frequency is 900 kHz, and each of the 256 beams measure  $1^\circ$  horizontal  $\times$   $20^\circ$  vertical, with  $0.18^\circ$  horizontal spacing. Its range is 1–55 m with range resolution of 2.5 cm. It provides the sonar equivalent of video images us-

ing illumination from a single source, with coarser resolution and slower update than video but independent of water clarity. Solid walls show as bright lines across the images; bright returns and shadows cast by raised or recessed features provide quasi-three-dimensional (3D) effects within the images. The sonar can be used to navigate the ROV and provide geometric data on the condition of underwater structures over much larger fields of view than are possible with video images in low-visibility water. The sonar weighs 1.9 kg and measures 18 × 10 cm in diameter. It costs about \$25,000–\$35,000 integrated onto an ROV, including sonar hardware and software but requires its own laptop computer to display and record the images.

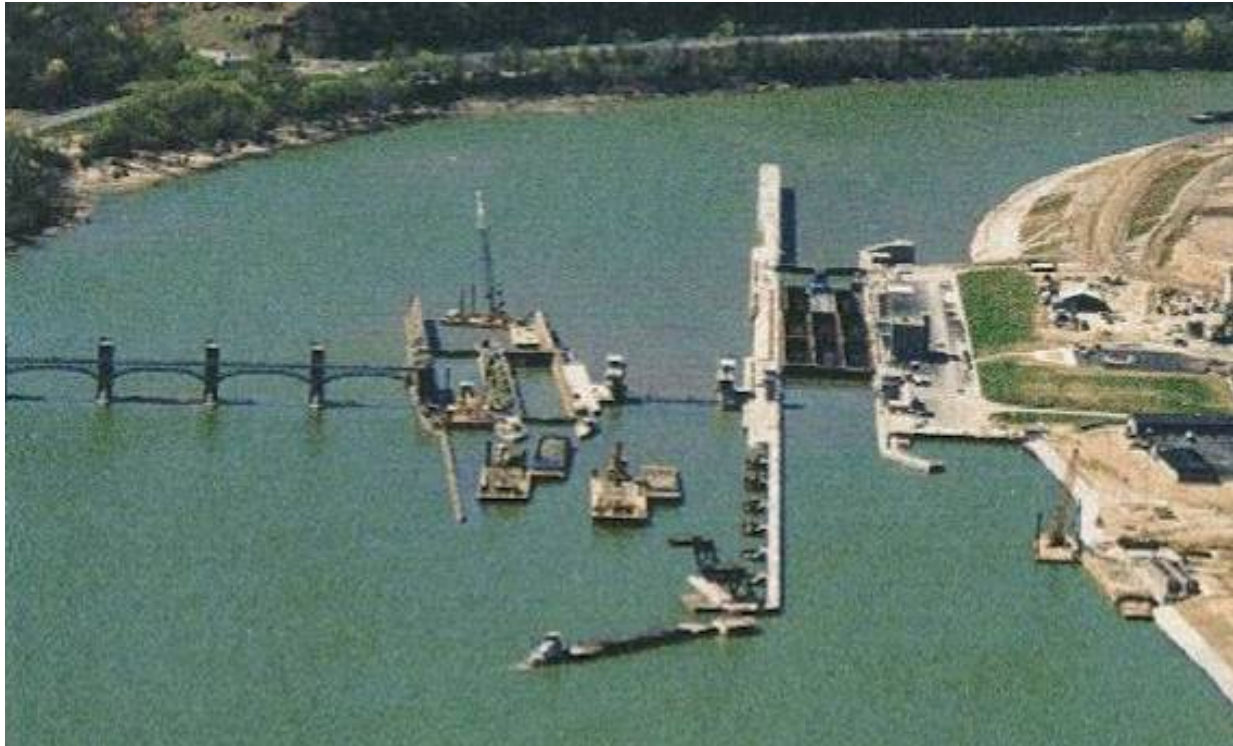
Figure 7. Winfield Locks and Dam on the Kanawha River, WV looking downstream. In this photo, the main lock chamber (center right) is filled with eight barges and a towboat. The older auxiliary locks in the center can accept individual barges. Four bays of the dam are visible across the center left.

Winfield Locks and Dam is located on the Kanawha River downstream from Charleston, WV, and consists of a relatively new 800- x 110-ft lock with miter gates, two smaller auxiliary locks with miter gates, and a dam with roller gates and stilling basin (Fig. 7). The Huntington District Web site ([www.lrh.usace.army.mil/projects/locks/win/](http://www.lrh.usace.army.mil/projects/locks/win/)) has additional information on the facility and its function.

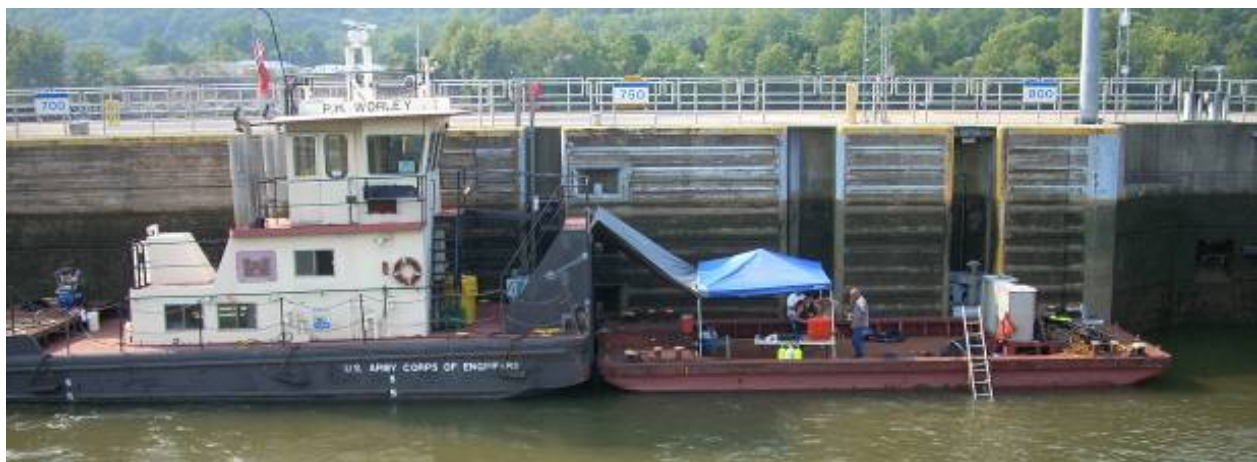
Figure 8. Dive-team barge and towboat moored at downstream end of 800-ft main lock chamber before inspection of lower miter gates.

Each morning, the dive team mobilized its equipment on a barge connected to a towboat (Fig. 8). During this time, some of its members, other Winfield staff, the authors, and other USACE personnel attended morning briefings by the vendors regarding the features and use of their ROVs. The vendors then mobilized their ROV equipment according to the day's inspection tasks. For four vendors, we operated the ROVs from the dive team's barge; the VideoRay demo operated from the land-side pier adjacent to the main lock chamber.

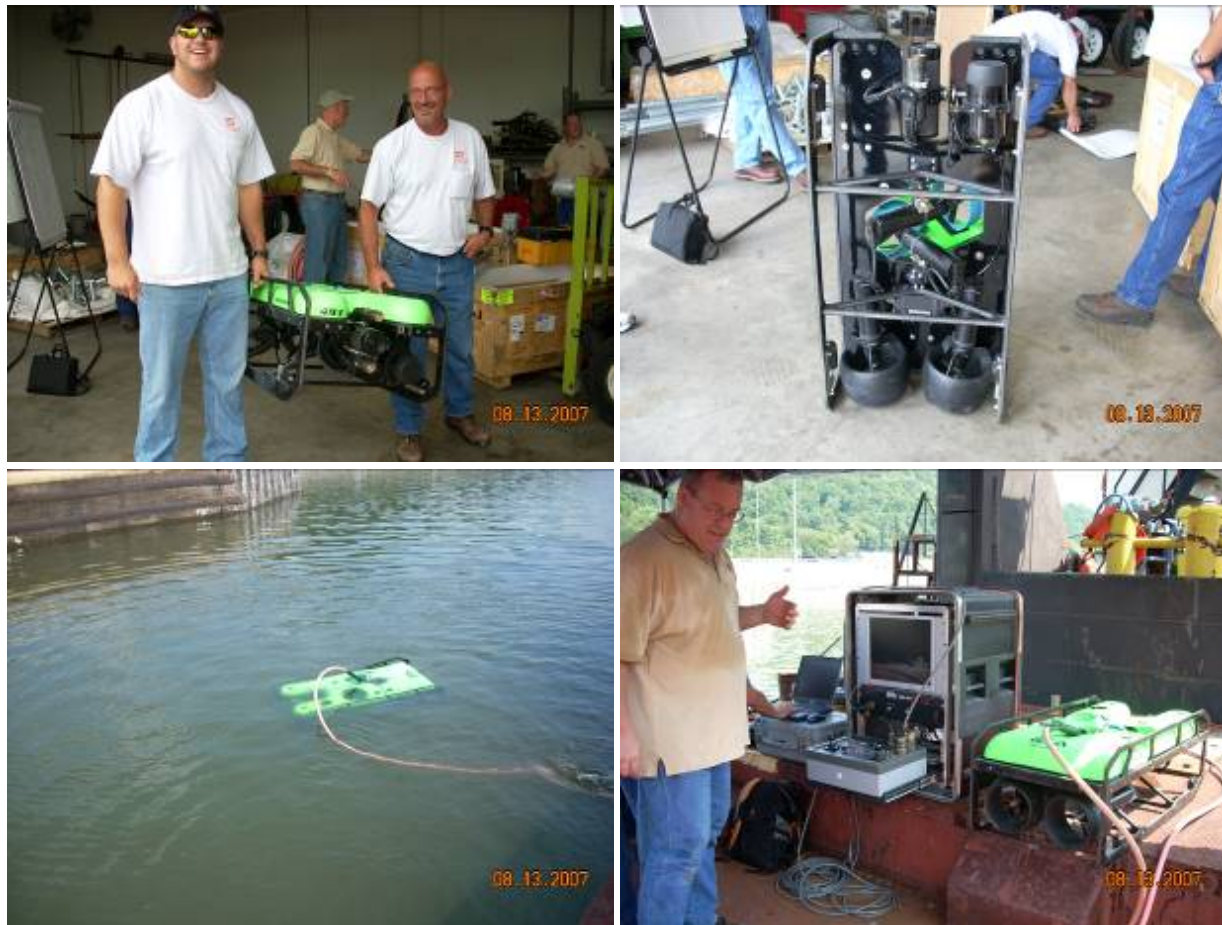
Figure A1. Deep Ocean Engineering system showing (clockwise from upper left): *Triggerfish* ROV carried by two divers; underside of ROV with longitudinal thrusters at bottom, diagonal thrusters in middle, tilting video camera and light in top-center slot, and BlueView sonar in top-right corner; ROV and topside control/display equipment; ROV and tether in water just upstream of auxiliary lock.

Deep Ocean Engineering *Triggerfish* ROV with BlueView P900E-20 imaging sonar (Fig. A1)

- Tilting color camera and light work well together.
- Sonar aids navigation (e.g., clear images of filling-culvert ports, walls gates, etc.), but requires experience to interpret images (e.g., to “filter” secondary returns); image update rate slow, many system reboots—communication problems related to tether.

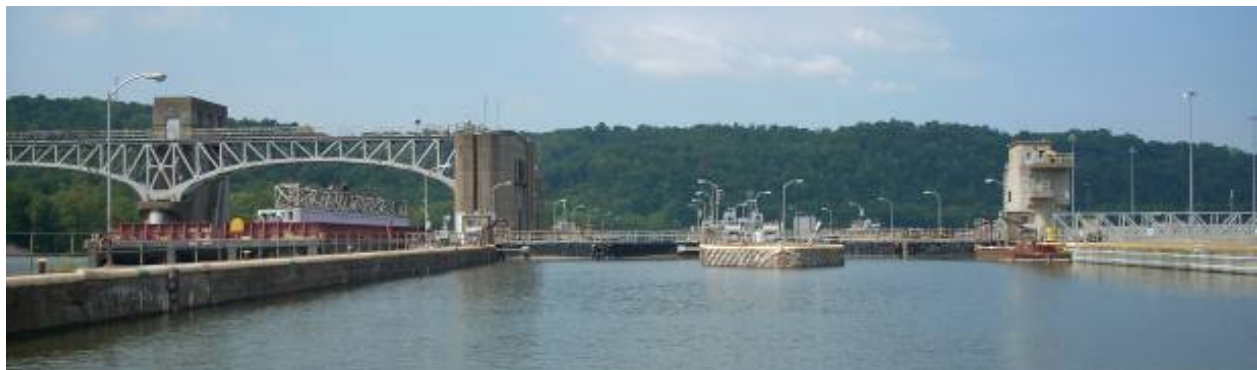
Figure A2. Winfield Locks and Dam twin auxiliary locks (center of photo) are located between the new main lock chamber (right) and dam gates (left). ROV deployments were just upstream of left auxiliary lock to inspect miter-gate seals and filling-culvert ports.

- Approximately 1-h mobilization time onto barge.
- Moored upstream of auxiliary lock (Fig. A2); water depth ~33 ft.
- One-person deployment, two-person recovery of ROV.

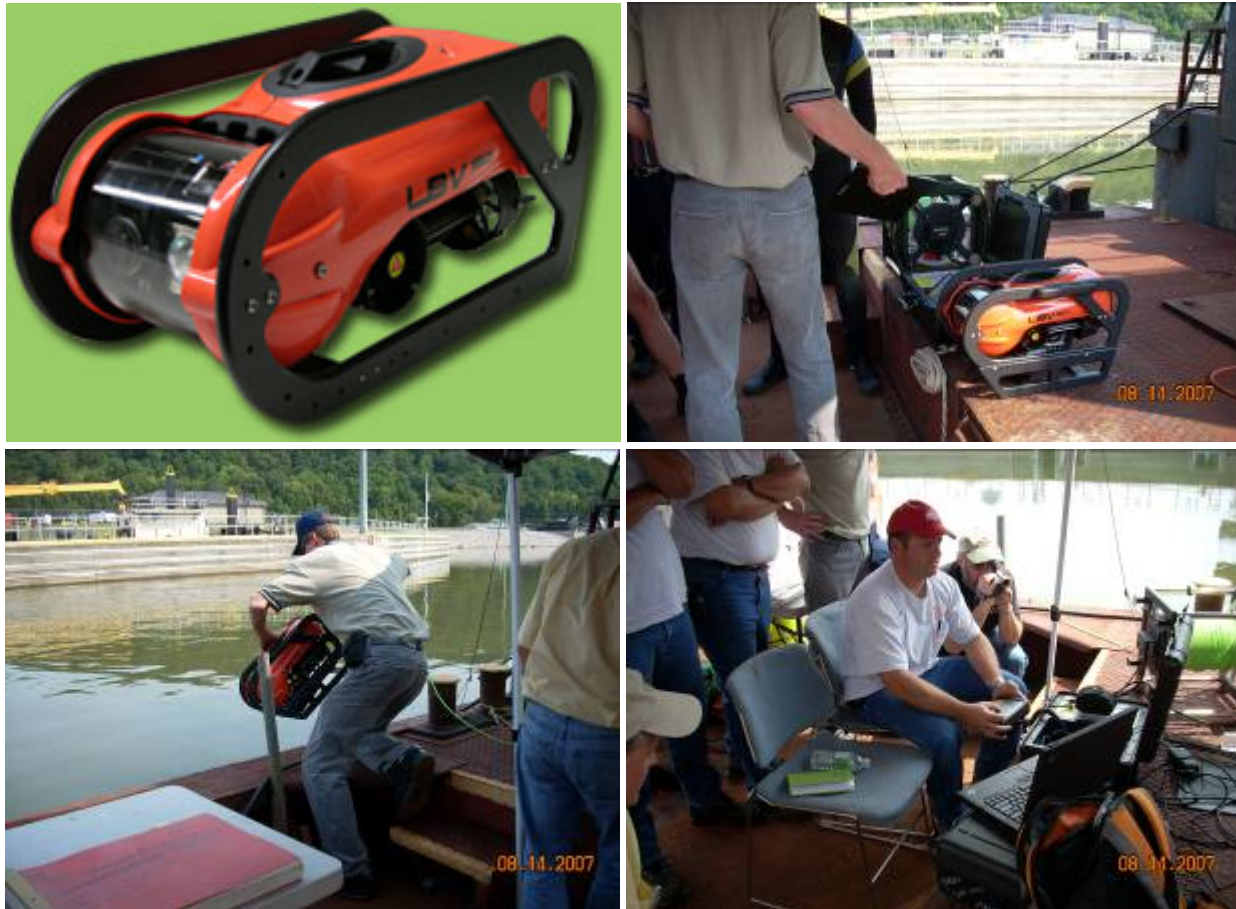
Figure A3. SeaBotix system showing (clockwise from upper left): LBV150SE ROV with color camera, black and white camera, and light mounted on tilt frame behind front cylindrical window; ROV with underside skid-mounted BlueView sonar, topside control/display unit, and tether reel; Scott Kinzel piloting ROV patiently and well; one-person deployment/recovery.

SeaBotix *LBV150SE* ROV with BlueView P900E-20 imaging sonar (Fig. A3).

- Tilting color camera, black and white camera, and light work well together.
- Sonar aids navigation (e.g., clear images of filling-culvert ports, walls, gates, etc.) but requires experience to interpret images (e.g., to “filter” secondary returns); image update fast and stable on fiber-optic tether; Fletcher has gained experience interpreting lock terrain on sonar.

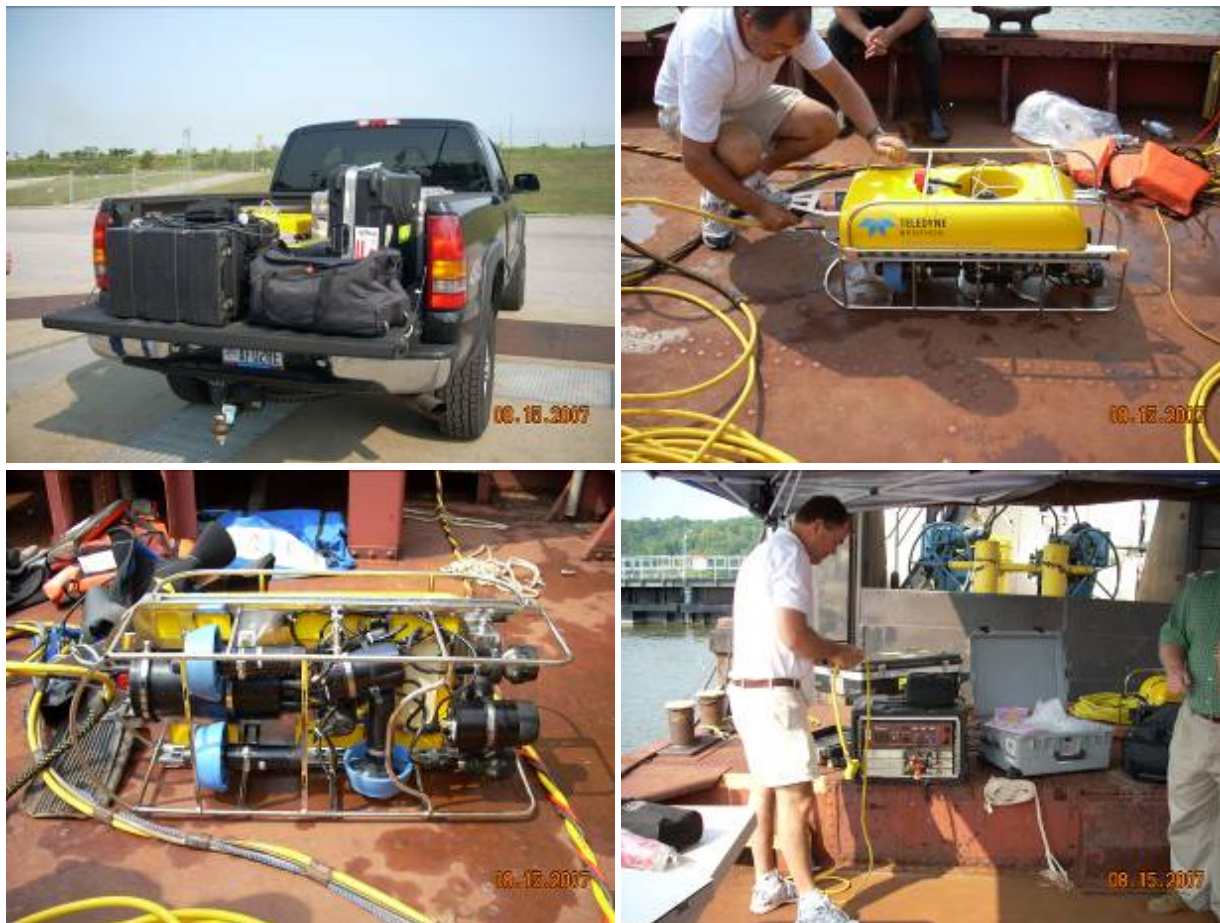
Figure A4. Teledyne-Benthos system showing (clockwise from top left): system components fill pick-up truck; *Stingray* ROV with stainless steel frame and thruster impellers; assembly of topside control and display equipment; underside of ROV with longitudinal thrusters at left end, lateral thruster and electronics housing in middle, and tilt bar with camera, lights, and sonar attached at right end.

- Teledyne-Benthos *Stingray* ROV with BlueView P900E-20 imaging sonar (Fig. A4).

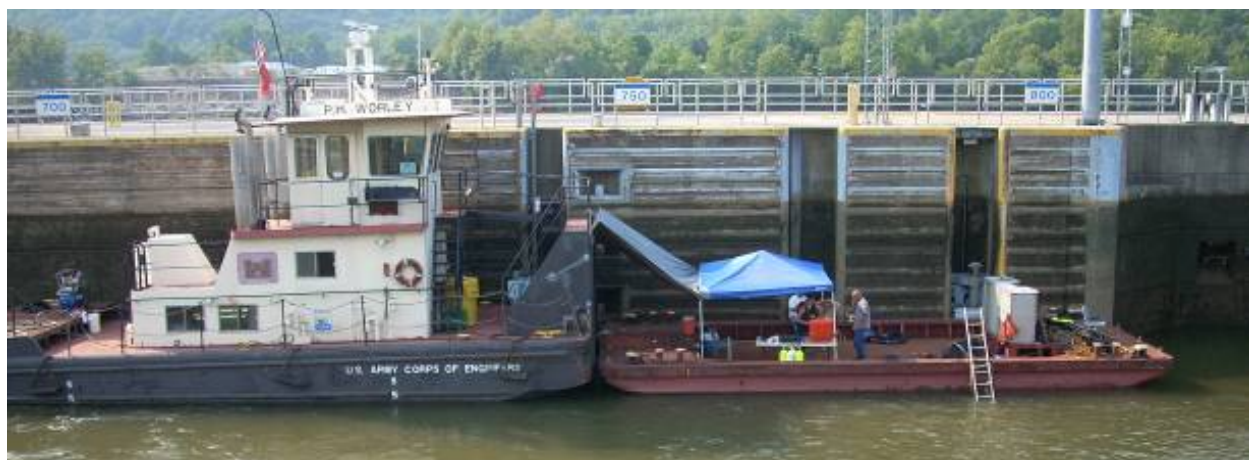
Figure A5. Barge and towboat moored at downstream end of 800-ft main lock chamber before inspection of lower miter gates.

- Approximately 1-hr mobilization time onto barge.
- Moored at downstream end of main lock chamber (Fig. A5) to inspect lower miter gates, water depth ~20 ft with gates open.

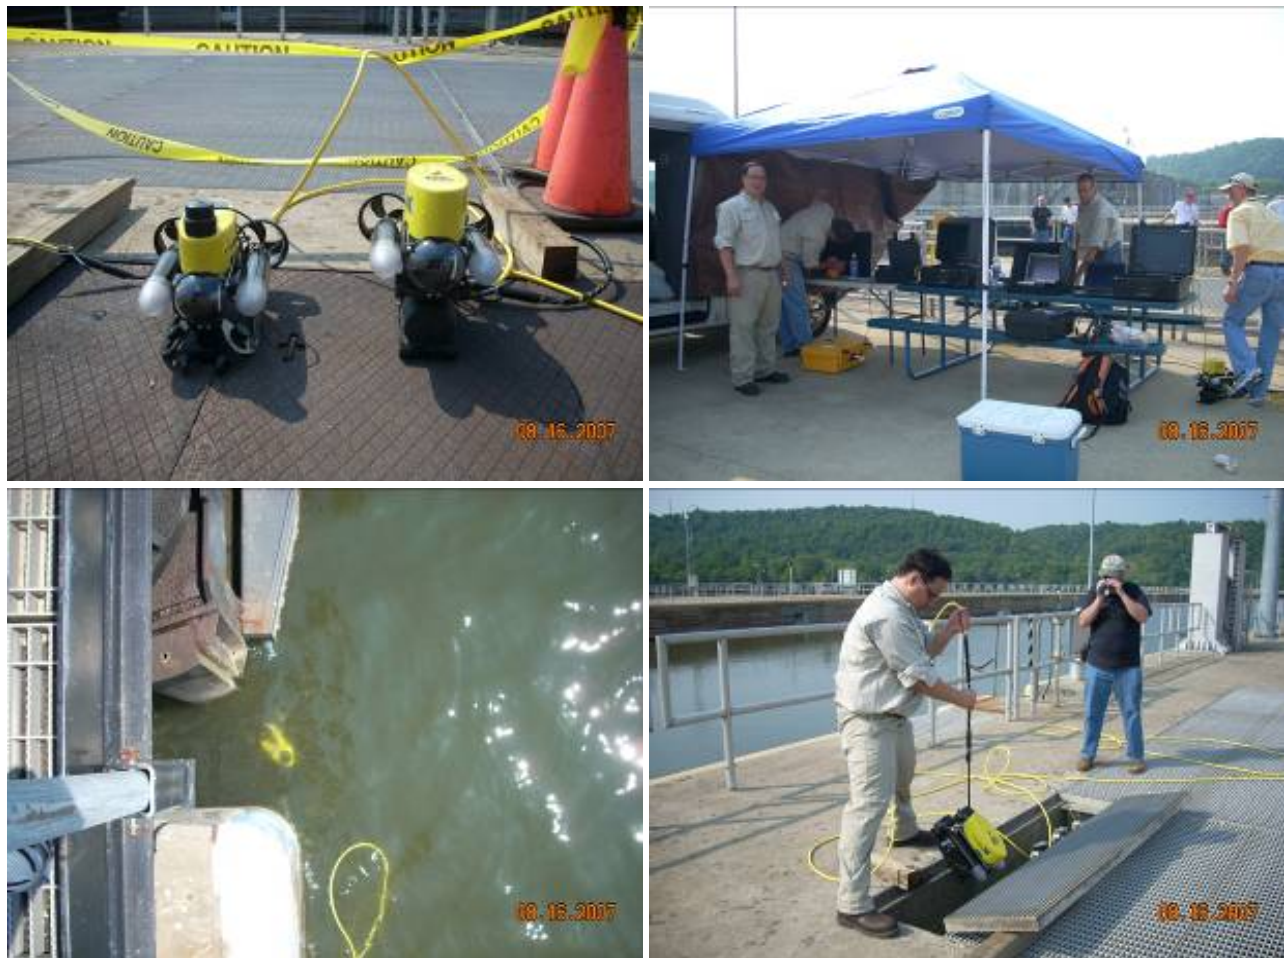
Figure A6. VideoRay systems showing (clockwise from upper left): two Pro 3 XE GTO vehicles with scanning sonar (left vehicle) and imaging sonar (right vehicle); topside control and display equipment for both ROVs; the ROV with imaging sonar being lowered into the land-side filling valve chamber to inspect the grease lines and valve seals; looking down on ROV with scanning sonar approaching the miter gate to inspect the quoin block, sills, and J-seals.

- ROV's small size and Jeff's experience allows him to inspect miter-gate quoin and pintle efficiently, with camera close enough to reveal details.
- Small-diameter tethers require infrequent management, depending on inspection tasks; careful tether management is needed when inspecting in valve chamber to avoid entanglement.
- VideoRay personnel deployed the DesertStar long-baseline acoustic positioning system in main lock chamber (four transponders placed at known locations on lock walls to triangulate position of ROV); they worked through several problems but were ultimately unable to operate the system successfully.

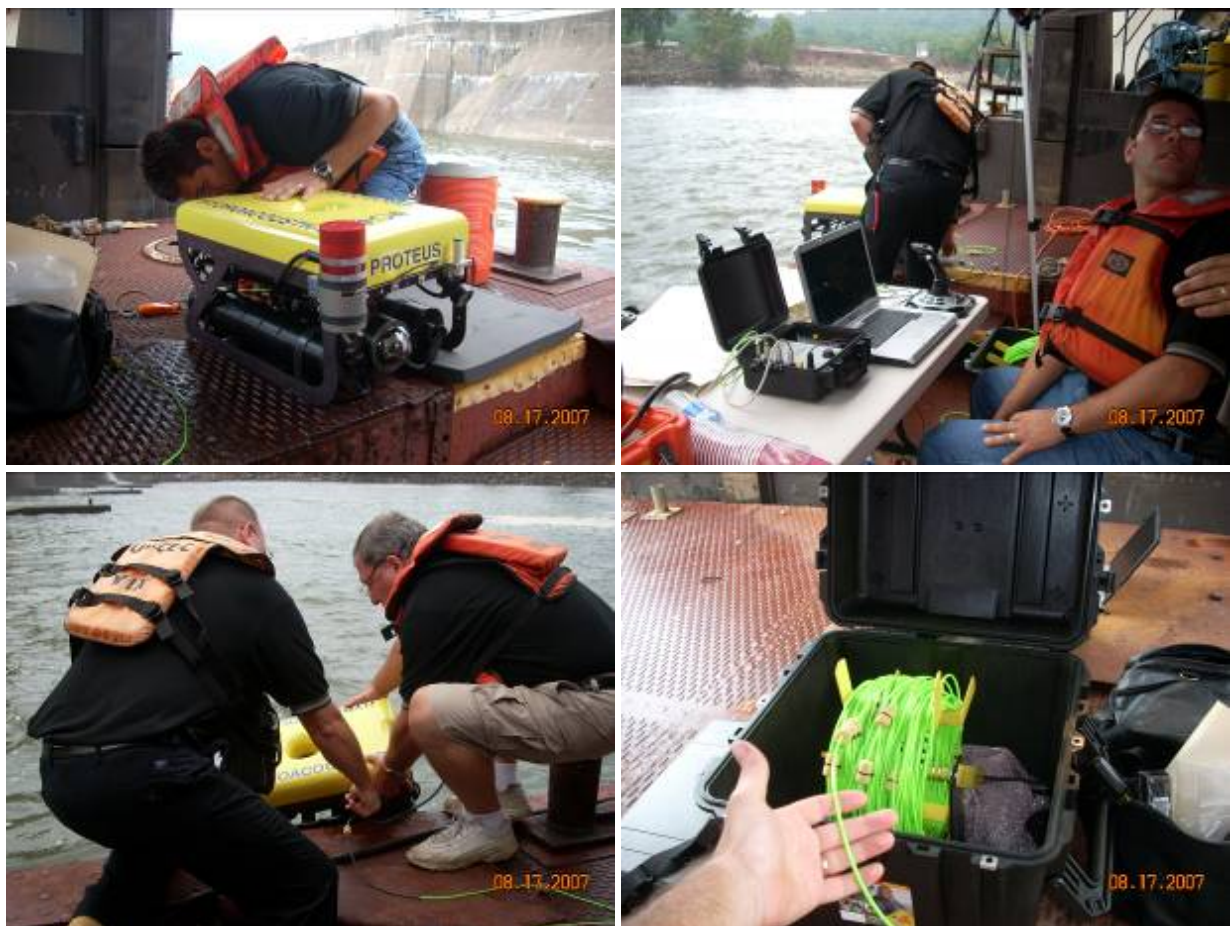
Figure A7. Hydroacoustics system showing (clockwise from upper left): *Proteus 500* ROV with vertically mounted Imagenex sonar (with red cap), tilt color camera, fixed lights, and two longitudinal battery tubes along bottom of vehicle; laptop-based operator station; thin tether with floats; two-person deployment.

- One operator, one person to manage tether.
- Small tether (3.5-mm diameter) used small floats to achieve slight positive buoyancy.
- Water visibility ~4 ft owing to leakage through gates; good video images at close range but still need sonar to navigate.

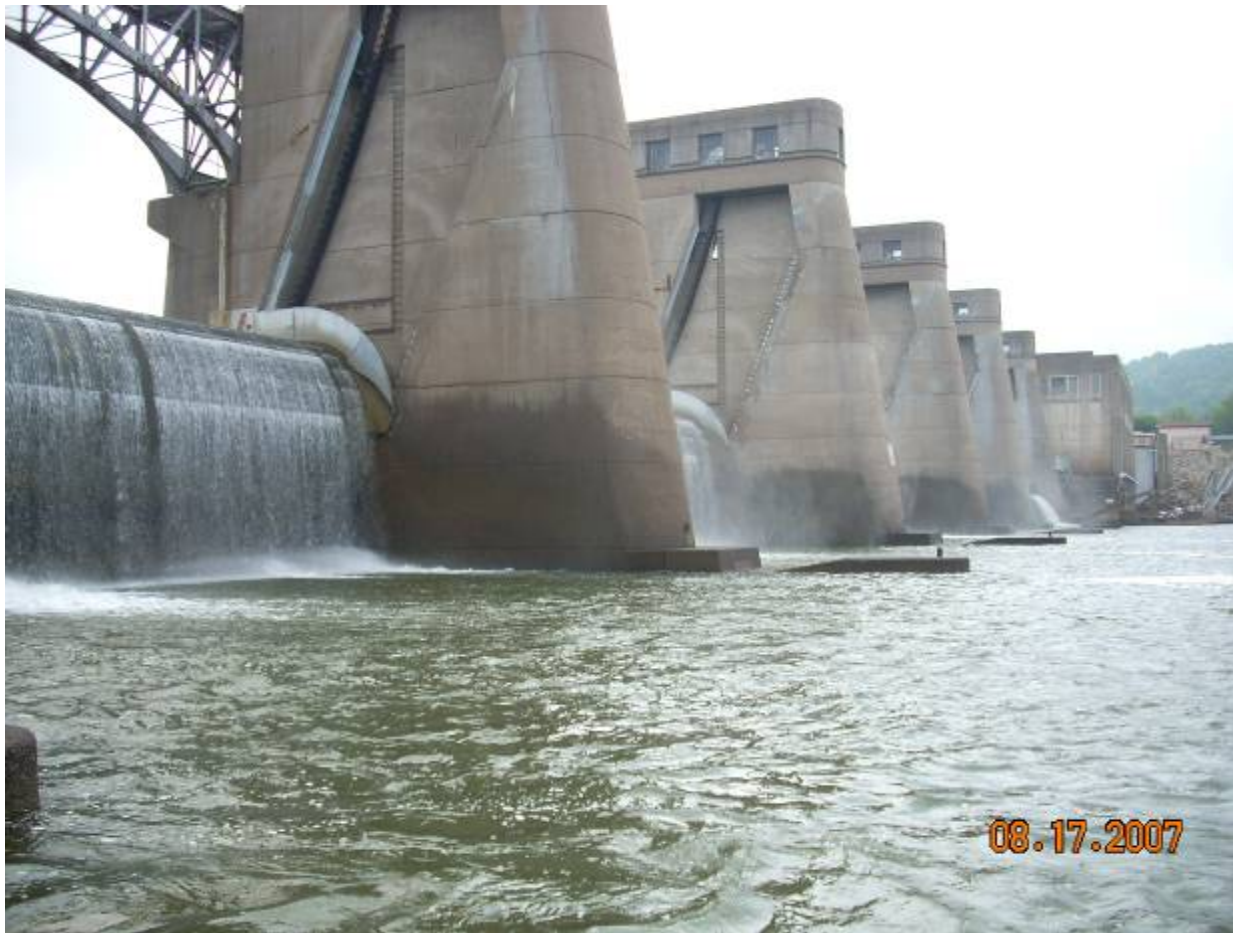
Figure A8. View when moored in stilling basin below dam, with gate 2 at left of picture.

- Dive coordinator prefers not to use divers to inspect basin downstream of gates 2 and 3 owing to leakage flow.
- Second dive—moored at edge of navigation channel approximately one-half mile downstream of lock to search for chains from lost floating moorings.
